INSPECTION

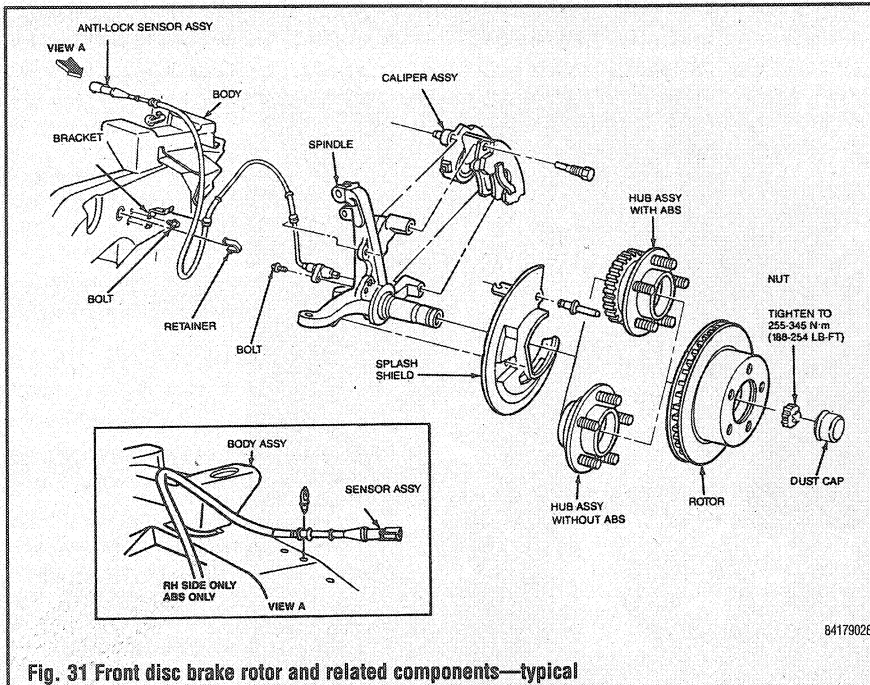
Fig. 31 Front disc brake rotor and related components—typical

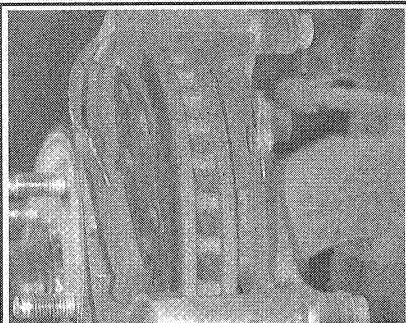
93149P31

Fig. 32 After removing the disc pads you can inspect the brake rotor thoroughly for scoring

Check the disc brake rotor for scoring, cracks or other damage. Check the minimum thickness and rotor runout.

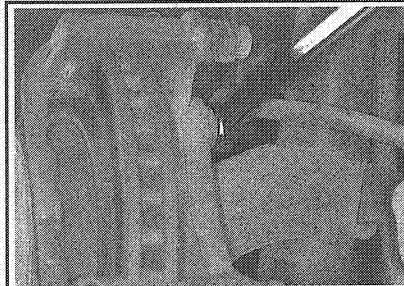
93149P30

Fig. 33 If the rotor has to come off, the disc support bracket has to be removed. This bracket has two bolts that hold it in place

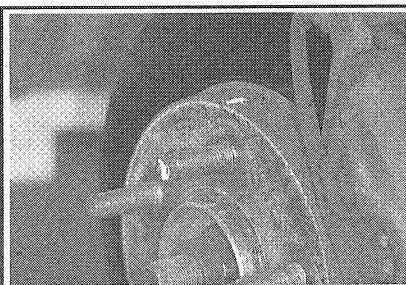
93149P21

Fig. 34 Before removing the caliper, matchmark the rotor and the stud (lug) to help prevent vibration from a rotor that is out of round

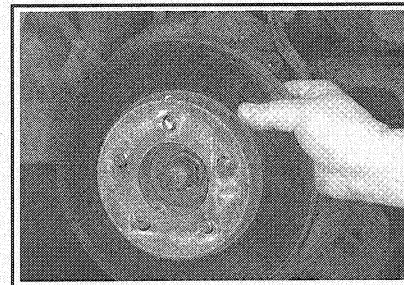
93149P07

Fig. 35 To remove the rotor, just slide it off the hub. Make sure it is marked on a stud and on the rotor "hat" for proper installation

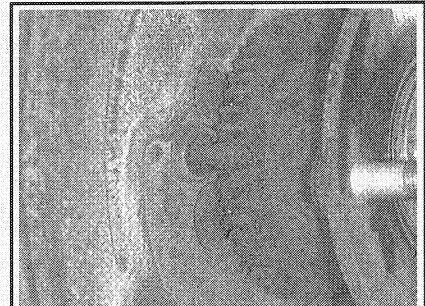
93149P25

Fig. 36 When the rotor has been removed, the anti-lock hub and sensor can be cleaned and inspected
