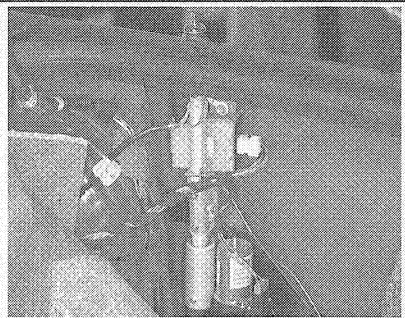
93140P33

Fig. 12 The antenna mounts in the luggage compartment against the support member

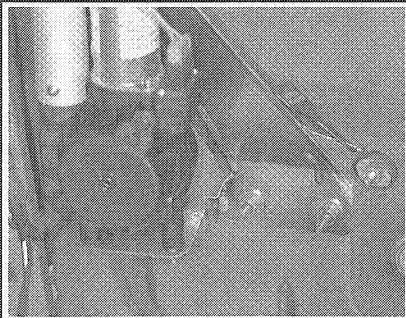
93140P11

Fig. 13 The motor and housing sit on a stand that is bolted to the support member

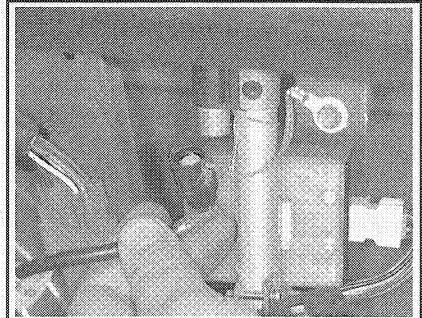
93140P12

Fig. 14 Unplug the antenna lead from the staff tube

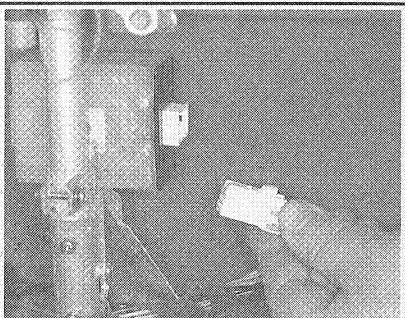
93140P58

Fig. 15 Unplug the connector to the motor

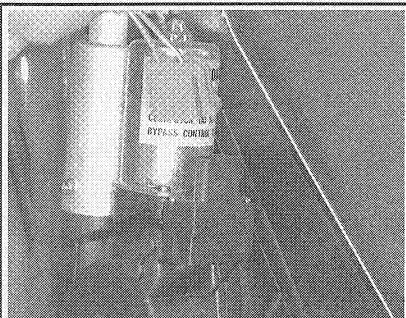
93140P57

Fig. 16 Unplug the connector to the relay

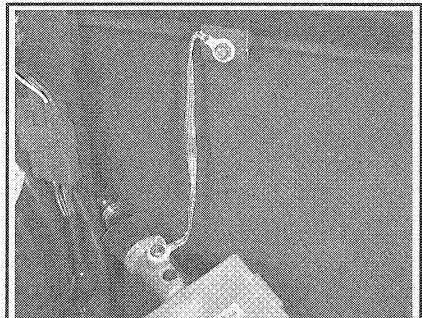
93140P56

Fig. 17 It's easier to remove the antenna from the support to gain access to the ground strap screws

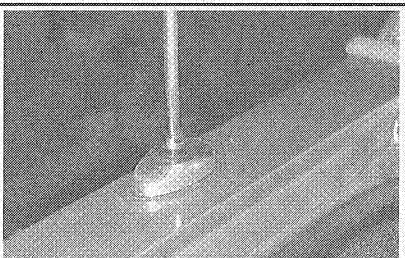
93140P42

Fig. 18 If the antenna motor still operates, but the staff does not move, or the staff is bent, or does not extend to its full height, a replacement staff kit is available that can be used without replacing the motor

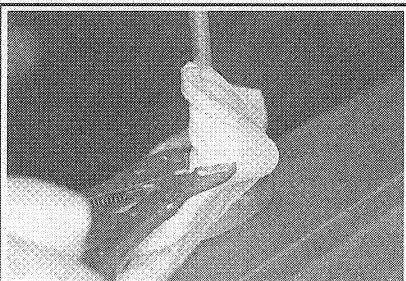
93140P41

Fig. 19 This locknut was removable using a locking pliers and a shop cloth (to protect the chrome nut). Unscrew the locknut to remove it

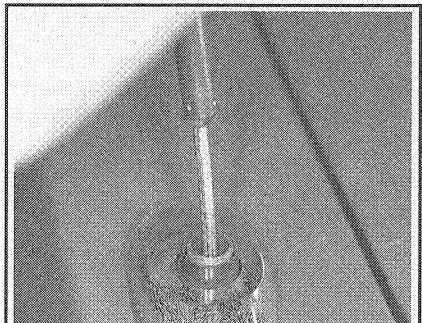
93140P43

Fig. 20 With the help of an assistant to raise the antenna, gently pull up on the staff to extricate it from the fender

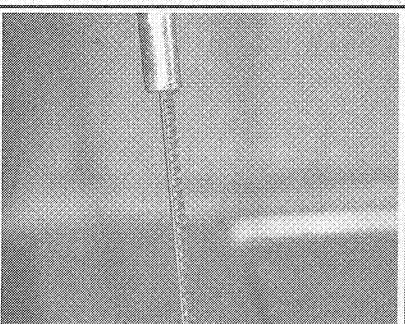
93140P40

Fig. 21 Continue pulling while raising the antenna until the entire drive comes out of the base

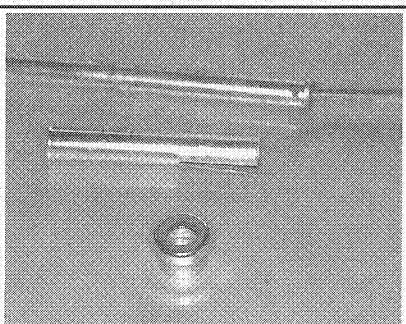
93140P38

Fig. 22 When the antenna is out, slide the bushing off and install it on the new staff, if not supplied
