DISASSEMBLY AND ASSEMBLY (Continued)

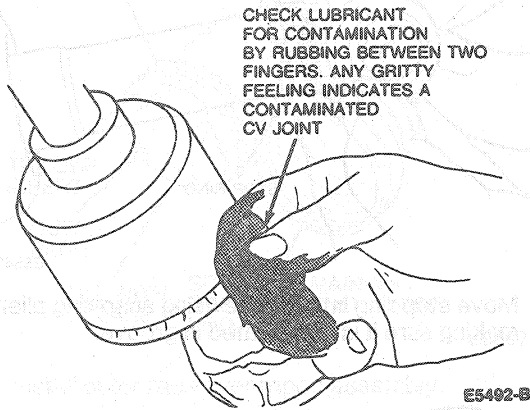
3. When replacing damaged CV joint boots, the grease should be checked for contamination. If the CV joints are operating satisfactorily, and the grease does not appear to be contaminated, add grease and replace the boot.

If the grease appears contaminated, proceed with a complete CV joint disassembly and inspection.

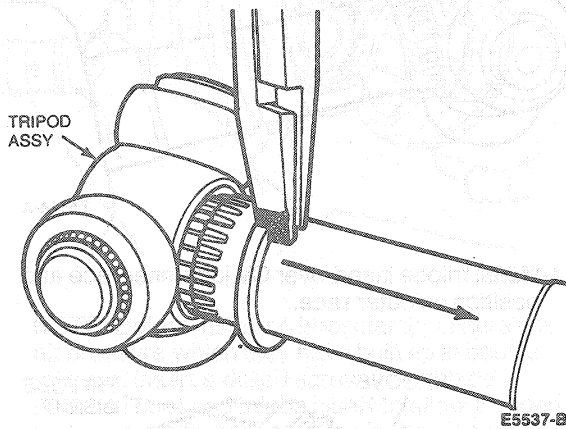
4. Move stop ring back on shaft using snap-ring pliers.

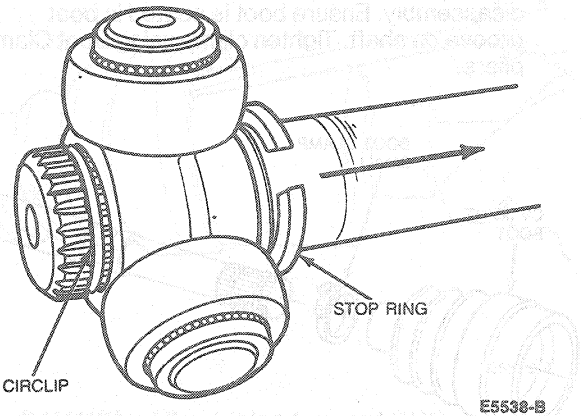
5. Move tripod assembly back on shaft to allow access to circlip.

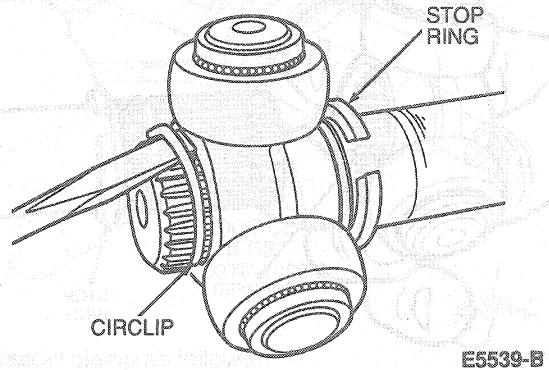
6. Remove circlip from shaft.

CAUTION: CIRCLIPS MUST NOT BE REUSED. REPLACE WITH NEW CIRCLIPS BEFORE REASSEMBLY.

CAUTION: Circlips must not be reused. Replace with new circlips before reassembly

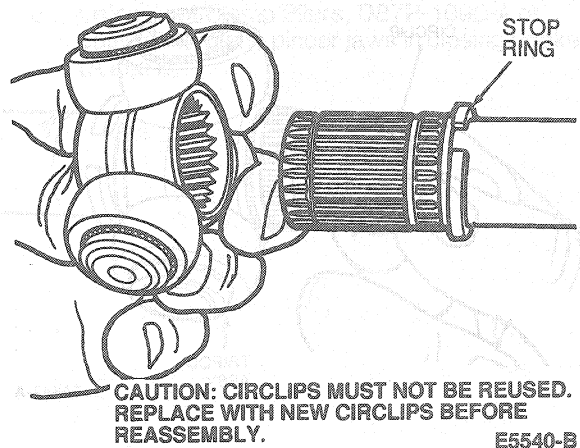
7. Remove tripod assembly from shaft. Remove boot if necessary.
