LOWER BODY SIDE STONE PROTECTION VINYL SERVICE (Continued)

Procedure For Repairing Surface Damage

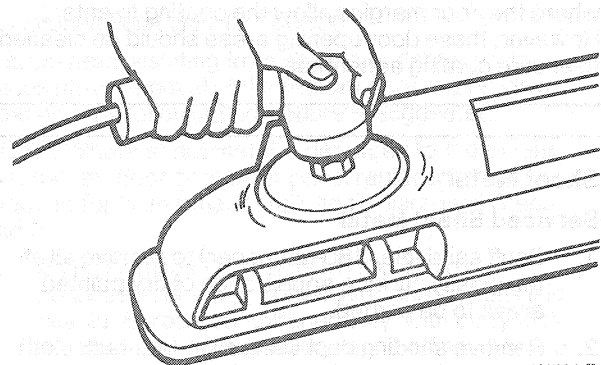
3. Feather edge the paint around repair area with No. 180-grit paper disc.
