## DIAGNOSIS AND TESTING (Continued)

**Camshaft Lobe Lift****Tools Required:**

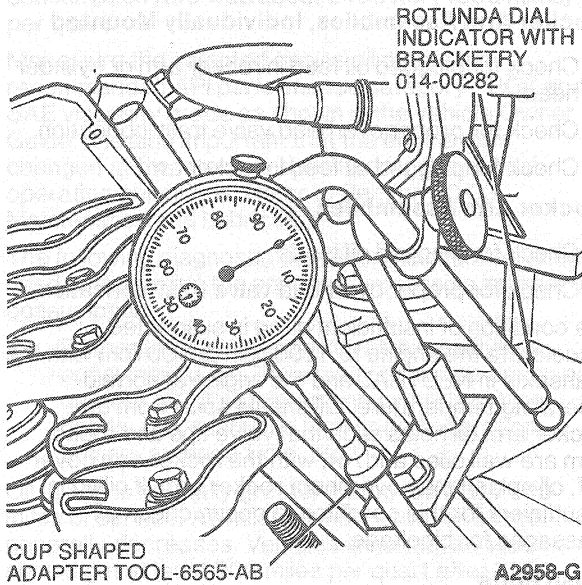
1. Remove valve rocker arm cover(s).
2. Remove rocker arm fulcrum bolts, fulcrum and rocker arm.
3. Ensure tappet is seated against cam. Install Rotunda Dial Indicator with Bracketry 014-00282 or equivalent in such a manner as to have ball socket adapter of indicator on top of tappet, or Cup Shaped Adapter TOOL-6565-AB or equivalent on top of push rod and in same plane as tappet or push rod movement.

4. Remove spark plugs.
5. Connect an auxiliary starter switch in starting circuit. Crank engine with ignition switch in OFF position. Bump crankshaft over until tappet is on base circle of camshaft lobe. At this point, tappet will be in its lowest position. If checking during engine assembly, turn crankshaft using a socket or ratchet.
6. Zero dial indicator. Continue to rotate crankshaft slowly until tappet is in fully raised position (highest indicator reading).
7. Compare total lift recorded on indicator with specifications.

8. To check accuracy of original indicator reading, continue to rotate crankshaft until indicator reads zero.
