OVERHAUL (Continued)

Inspection

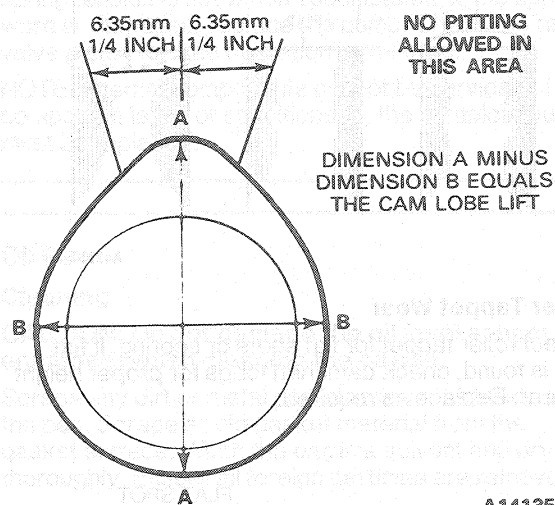
To measure the camshaft lobe lift, proceed as follows:

1. Measure distance between major (A-A) and minor (B-B) diameters of each cam lobe with a Vernier caliper and record readings. The difference in readings on each cam diameter is lobe lift.
2. If readings do not meet specification, replace camshaft. For Specifications, refer to Section 03-01A (3.0L), 03-01B (3.0L/3.2L SHO) or 03-01C (3.8L).

Inspect the camshaft lobes for scoring and signs of abnormal wear. Lobe pitting in the general area of the lobe toe is not detrimental to the operation of the camshaft; therefore, the camshaft should not be replaced unless the lobe lift loss has exceeded specification or pitting has occurred in the lobe lift area.
