ADJUSTMENTS (Continued)

Quick Connect Power Steering Fitting, Atsugi Seal Replacement

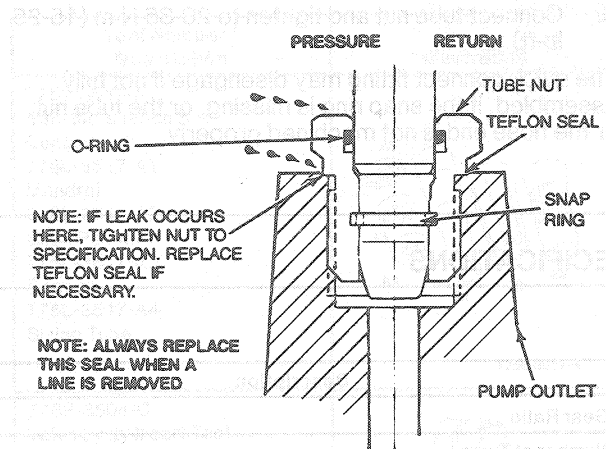
G5248-B

If a leak occurs between the tubing and tube nut, replace the hose assembly. If a leak occurs between the tube nut and the pump outlet, replace the plastic washer.
