## Diagnostic Trouble Code 33

## Passenger Side Air Bag Circuit High Resistance or Open

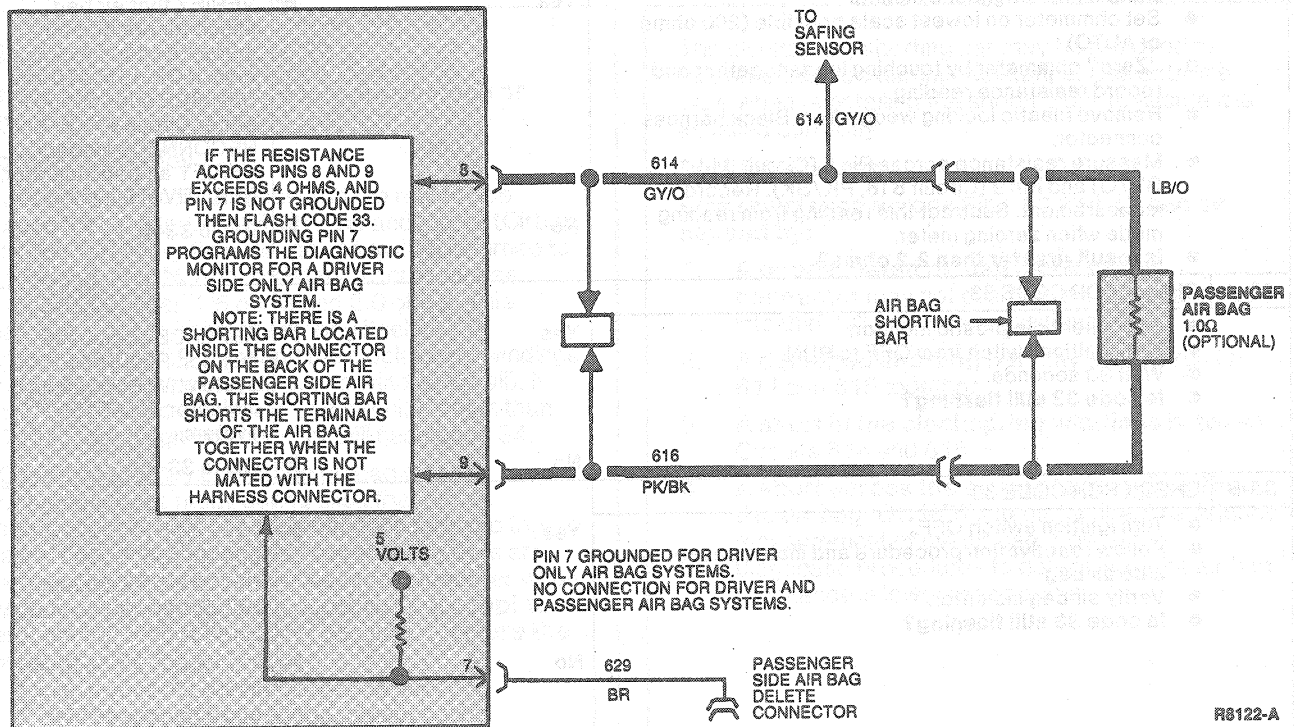
## Electrical Schematic—Diagnostic Trouble Code 33

The diagnostic monitor measures the resistance across Pin 8 (Circuit 614) GY/O and Pin 9 (Circuit 616) PK/BK every time the ignition switch is turned to the ON position. Normal resistance across these circuits is between 0.9 ohms and 1.1 ohms. This resistance comes from the passenger side air bag itself. If the vehicle is NOT equipped with a passenger side air bag, Pin 7 of the diagnostic monitor should be connected to ground. Connecting Pin 7 to ground programs the diagnostic monitor to ignore high resistance on the passenger side air bag circuits. If the resistance across these two circuits exceeds 4.0 ohms and Pin 7 is not grounded, the diagnostic monitor will flash code 33.

1. An open circuit or high resistance in the wiring harness in Circuit 614 (GY/O) or 616 (PK/BK).
2. An open circuit or high resistance in the passenger side air bag. **DO NOT** attempt a direct resistance measurement of the air bag. Follow the diagnostic procedures to determine if the air bag resistance is higher than normal.
