TRANSAXLE

SECTION 07-01 Transaxle, Automatic—AXODE (AX4S)

The AXODE (AX4S) automatic overdrive transaxle is a fully automatic transaxle with four forward speeds and REVERSE, NEUTRAL and PARK.

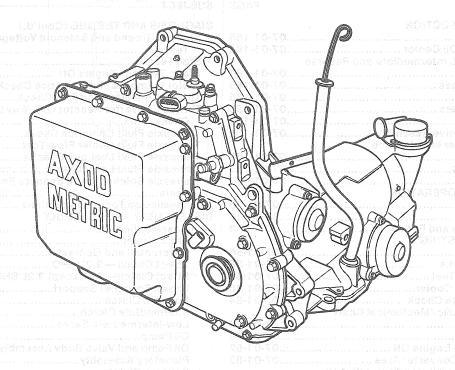
D827-A

The AXODE (AX4S) has two planetary gearsets and a combination planetary / differential gearset. Four multiple plate clutches, two band assemblies and two one-way clutches act together for proper operation of the planetary gearsets.

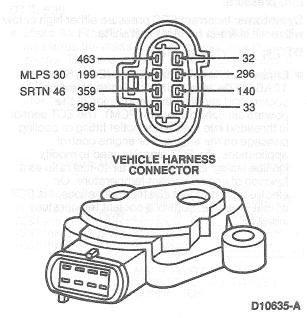
• Manual Lever Position (MLP) 7A247: The powertrain control module (PCM) sends a voltage signal to the manual lever position (MLP) sensor. The MLP sensor incorporates a series of step-down resistors which act as a voltage divider. The PCM monitors this voltage which corresponds to the position of the manual lever. The MLP is located on the outside of the transaxle at the manual lever.

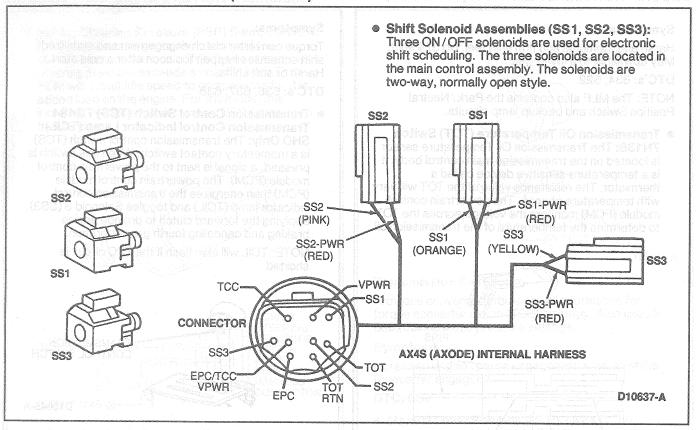
Transmission Function:

Solenoids SS1, SS2, and SS3 provide gear selection of 1st through 4th by controlling the pressure of the three shift valves and the forward clutch control valve.

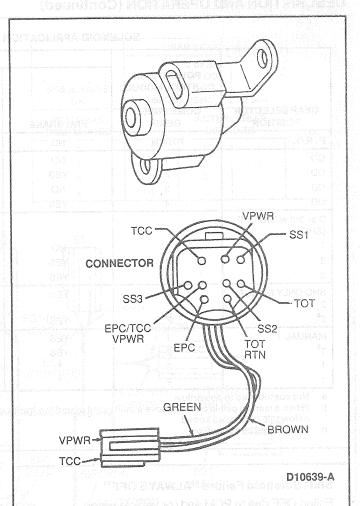
Torque Converter Clutch (TCC) 7G136
 Solenoid: Is used in the transaxle control system to control the application, modulation and release of the torque converter clutch.

Used to engage the torque converter clutch.

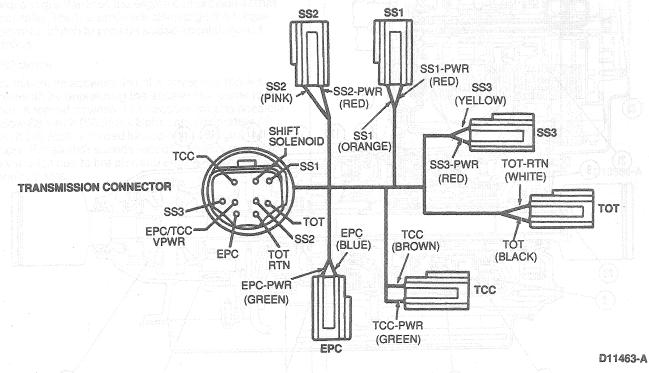
WIRE COLOR	CIRCUIT DESCRIPTION	PCM TEST PINS
BL	EPC BORRE	38
Υ	SS3 HOTGUD HEARDS!	55
GR	EPC/TCC VPWR	37, 57
BR	TCC CHAR TIME ENDING	53
: W	TOT RETURN SAMA 19 BY AK	46
ВК	TOT	49
PK	SS2 BEFORE YER AND SOME PARTY	52
0	SS1 (1428-84 11) 414-10 (1444) 1/200	51
R	VPWR	37, 57

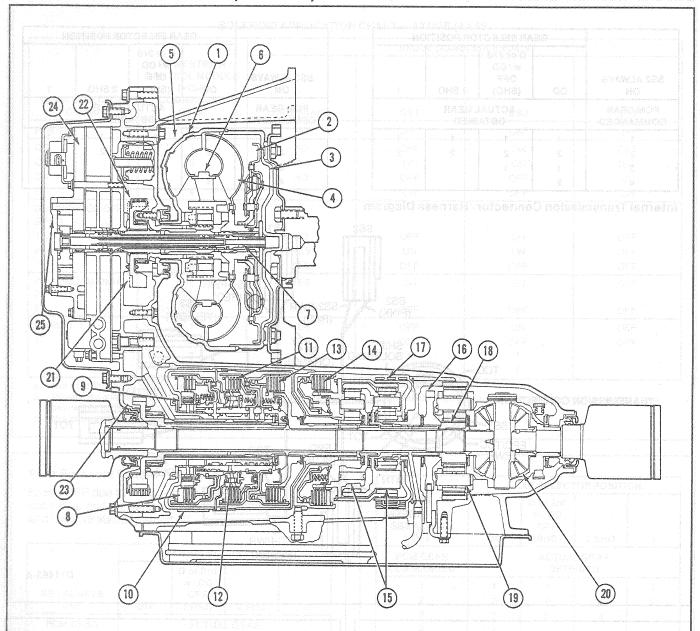
ITEM DESCRIPTION

- TORQUE CONVERTER
- TORQUE CONVERTER CLUTCH (PISTON PLATE CLUTCH) AND DAMPER ASSEMBLY)
- CONVERTER COVER
- TURBINE
- IMPELLER
- REACTOR OIL PUMP DRIVESHAFT
- FORWARD CLUTCH
- LOW ONE-WAY CLUTCH
- 10. OVERDRIVE BAND
 11. DIRECT CLUTCH
 12. DIRECT ONE-WAY CLUTCH

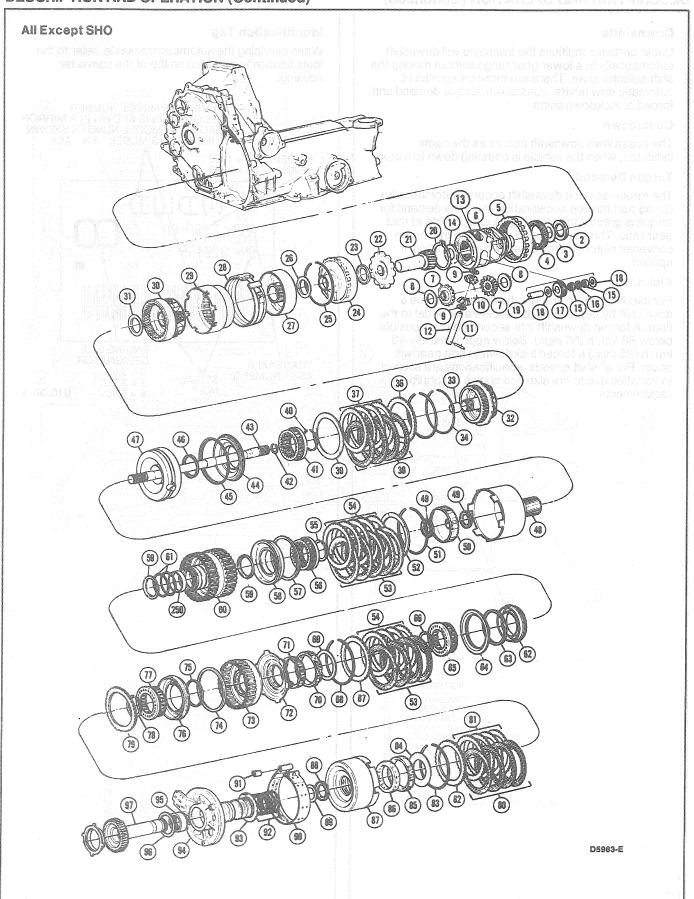
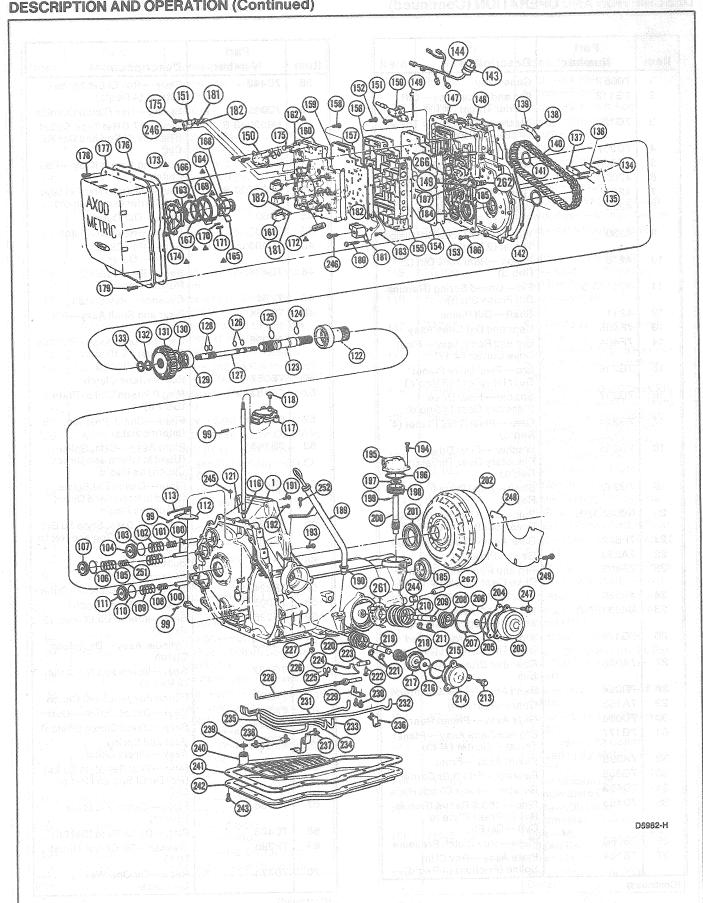
Item	Part Number	Description
1	7005	Case Assy
2	7G112	Brg and Race Assy—Diff Carrier Thrust (#19)
3	7G103	Washer—Diff Carrier Thrust (#18)—Sel Fit
4	7G237	Gear—Governor Drive
5	7F343	Gear—Final Drive Ring
6	4205	Case—Transaxle Diff Gear
7	4236	Gear—Diff Side (2 Reg'd)
8	4228	Washer—Diff Side Gear Thrust (2 Reg'd)
9	4230	Washer—RR Axle Diff Pinio Thrust (2 Reg'd)
10	4215	Pinion—Rear Axle Diff (2 Reg'd)
11	305110-S	Pin—Coiled Spring (Retains Diff Pinion Shaft)
12	4211	Shaft—Diff Pinion
13	7F465	Gear and Diff Case Assy
14	7F404	Brg and Race Assy—Final Drive Carrier (# 17)
15	7G216	Brg—Final Drive Planet Gear Needle (168 Req'd)
16	7G217	Spacer—Final Drive Planetary Gear (4 Req'd)
17	7G214	Gear—Final Drive Planet (4 Req'd)
18	7G215	Washer—Final Drive Planetary Gear Thrust (8 Req'd)
19	7G213	Shaft—Final Drive Pinion (4 Req'd)
20	N803202-S	Ring—77.3 Ret Ext (Retain Pinion Shafts into Carrier)
21	7F342	Gear Assy—Final Drive Sun

22	7A233	Gear—Parking
23	7F405	Brg and Race Assy—Final Drive Gear Thrust (# 16)
24	7A130	Support Assy—Planet Gear
25	N803197-S	Ring—150.7 Ret Int (Used as Rear Support Ret Ring)
26	7G178	Brg and Race Assy—Sun Gear Thrust—RR (#15)
27	7A626	Gear and Drum Assy—RR Sun
28	7D034	Band Assy—Low and Interm
29	7A153	Gear—Rear Ring
30	7D006	Gear Assy—Planet Rear
31	7G177	Brg and Race Assy—Planet Thrust—Center (#13)
32	7A398	Planet Assy—Front
33	7G355	Bearing—Frt Plt Gr Carrier
34	7D483	Retainer—Rear Clutch Plate
35	7D483	Ring—153.9 Ret Int (Retain Rev Cl Press Plate to Cyl)—Sel Fit
36	7B066	Plate—Rev Clutch Pressure
37	7B164	Plate Assy—Rev Cl Int
٠. ا	• • • • • • • • • • • • • • • • • • •	Spline (Friction) (4 Reg'd)

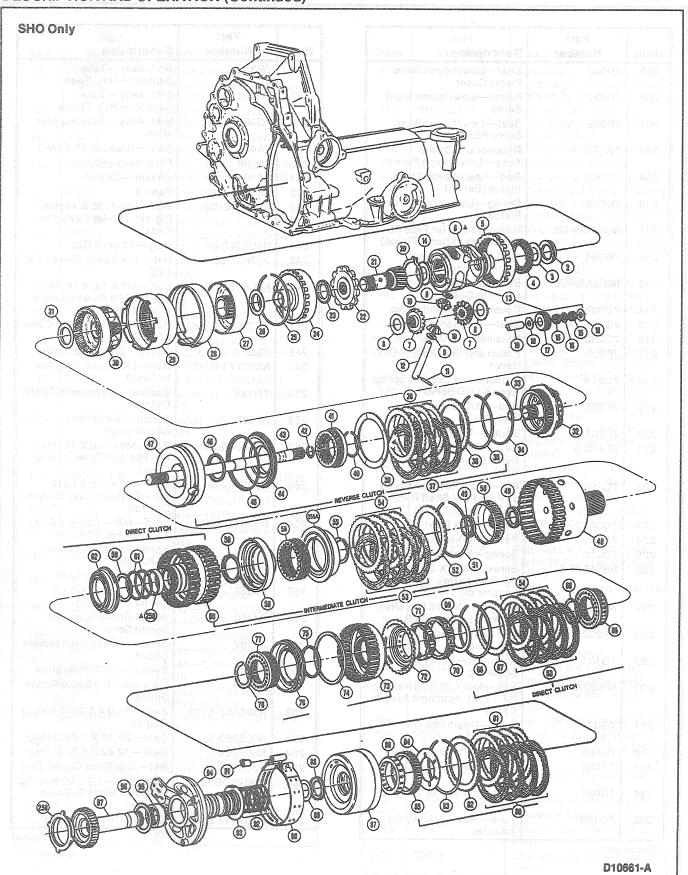
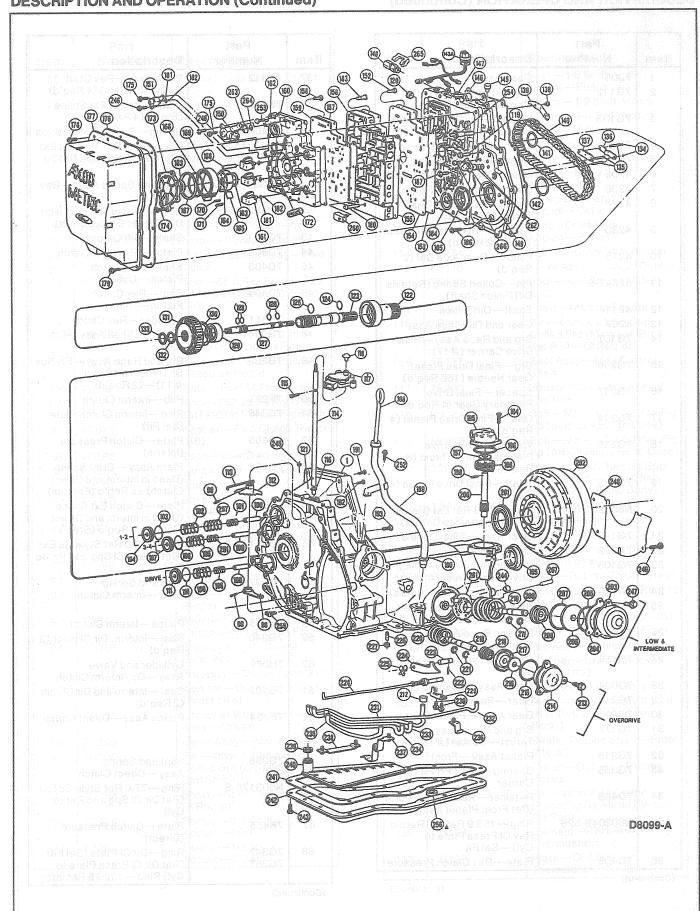
ltem	Part Number	Description
1	7005	Case Assy
2	7G112	Brg and Race Assy—Diff Carrier Thrust (#19)
3	7G103	Washer—Diff Carrier Thrust (#18)—Sel Fit
4	7G237	Gear—Governor Drive
5	7G334	Gear—Final Drive Ring
6	4205	Case—Transaxle Diff Gear
7	4236	Gear—Diff Side (2 Reg'd)
8	4228	Washer—Diff Side Gear Thrust (2 Reg'd)
9	4230	Washer—RR Axle Diff Pinio Thrust (2 Req'd)
10	4215	Pinion—Rear Axle Diff (2 Req'd)
11	67847-S	Pin—Coiled Spring (Retains Diff Pinion Shaft)
12	4211	Shaft—Diff Pinion
13	4207	Gear and Diff Case Assy
14	7G107	Brg and Race Assy—Final Drive Carrier (#17)
15	7G216	Brg—Final Drive Planet Gear Needle (168 Req'd)
16	7G217	Spacer—Final Drive Planetary Gear (4 Req'd)
17	7G214	Gear—Final Drive Planet (4 Req'd)
18	7G215	Washer—Final Drive Planetary Gear Thrust (8 Req'd)
19	7G213	Shaft—Final Drive Pinion (4 Req'd)
20	N803202-S	Ring—77.3 Ret Ext (Retain Pinion Shafts into Carrier)
21	7G193	Gear Assy—Final Drive Sun

22	7A233	Gear—Parking
23	7G106	Brg and Race Assy—Final Drive Gear Thrust (# 16)
24	7A130	Support Assy—Planet Rear
25	N803197-S	Ring—150.7 Ret Int (Used as Rear Support Ret Ring)
26	7G178	Brg and Race Assy—Sun Gear Thrust—RR (#15)
27	7B459	Gear and Drum Assy—RR Sun
28	7D034	Band Assy—Low and Interm
29	7G211	Gear—Rear Ring
30	7G224	Gear Assy—Planet Rear
31	7G177	Brg and Race Assy—Planet Thrust—Center (#13)
32	7G218	Planet Assy—Front
33	7G355	Bearing—Assy Frt Plt Gr Carrier
34	7D483	Retainer—Rear Clutch Plate (Ret Front Planet Assy)
35	N803049-52S	Ring—153.9 Ret Int (Retain Rev CI Press Plate to Cyl)—Sel Fit
36	7D406	Plate—Rev Clutch Pressure
